**ENGINEERING EVALUATION OF THE RED BLUFF RESEARCH
PUMPING PLANT ON THE SACRAMENTO RIVER IN NORTHERN CALIFORNIA:
1995-1998**

**A Summary Report
Red Bluff Research Pumping Plant
Report Series: Volume 6**

**K. W. Frizell
Bureau of Reclamation
Water Resources Research Laboratory
P.O. Box 25007
Denver, CO 80225-0007**

September 1999

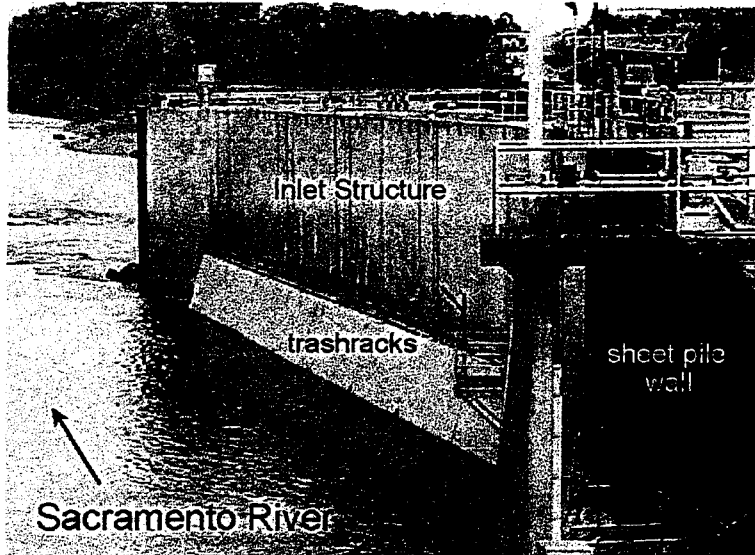
Figure 9. Inlet structure including trashracks. *The inlet structure to the RBRPP includes 160 ft of trashracks with 45-degree angled bars with $2\frac{1}{2}$ inch openings.*

The trashrack orientation has been changed once since the initial conditions. All of the racks were oriented so that the bars were angled downstream, or away from the flow. This orientation makes the trashracks similar to louver lines. Louvers have been used to guide fish away from dangerous flow conditions, such as pumping plants [Bates and Vinsonhaler 1957, Ruggles and Ryan 1964]. In addition to this change in bar orientation, one 18-inch-high plate was bolted on the trashracks at the bottom of the panels. Subsequent operation has shown that sediment deposition continues, maybe even to a greater extent depthwise, due to the addition of this solid plate at the bottom of the structure.

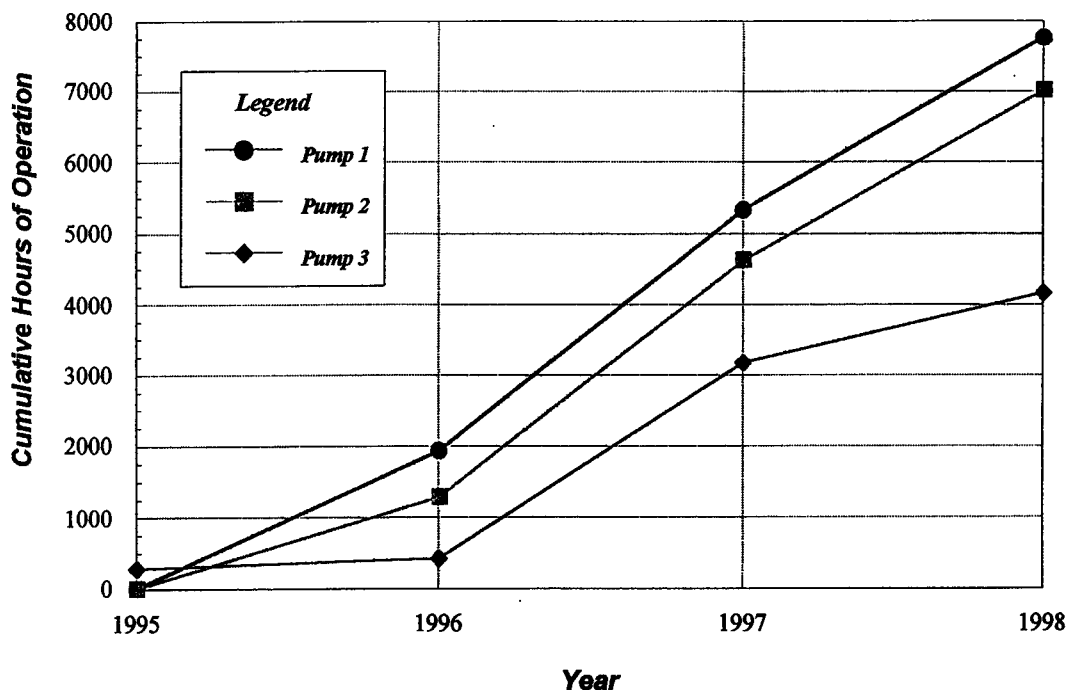
Over the course of the evaluation period covered in this report (1995-1998), the pumps operated rather sporadically due to design flaws as well as installation problems. The total cumulative hours of operation as a percent of the total possible hours of operation vary from about 13 percent for the Wemco-Hidrostal to 22 to 25 percent for the CPC Archimedes pumps, figure 11.

Figure 11. Cumulative hours of pumps operation. Total cumulative hours of pump operation by year for the period of evaluation, 1995-1998.

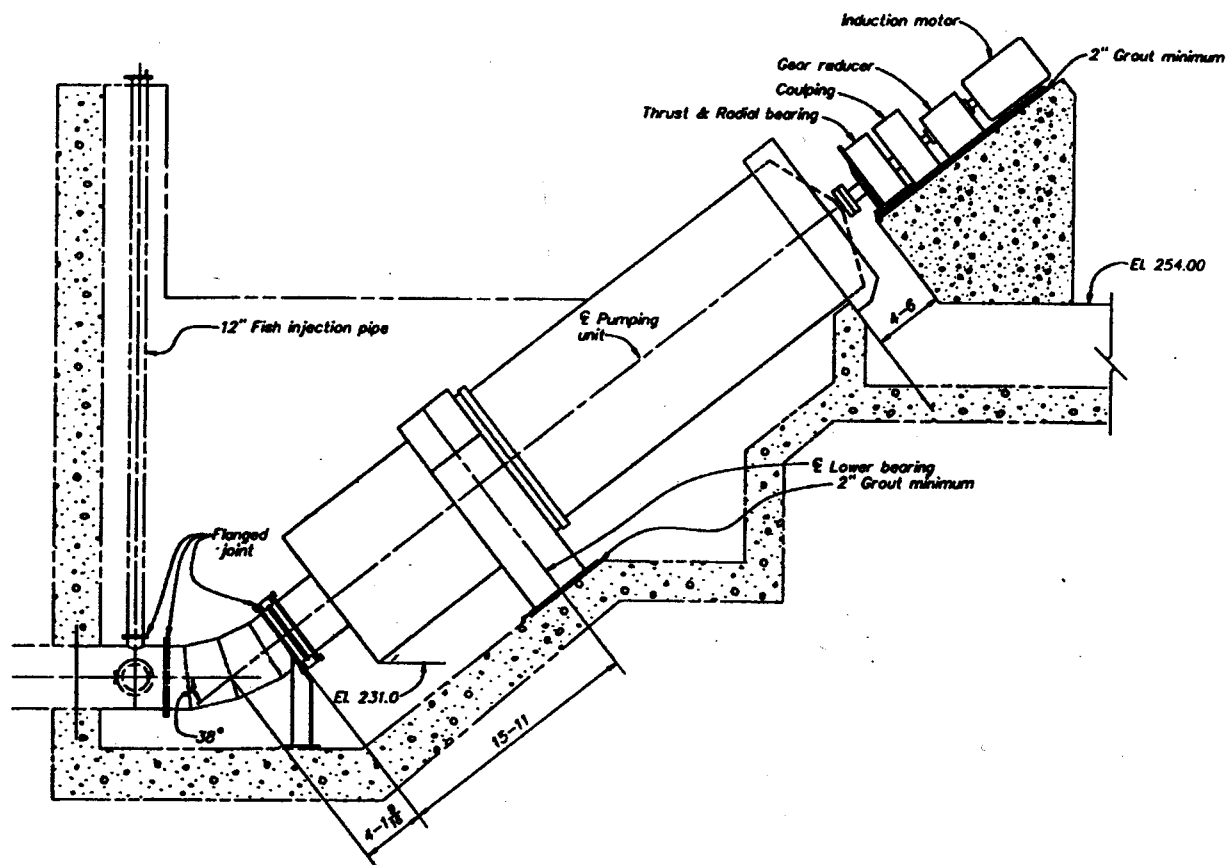
Figure 13. Sealed inlet Archimedes Installation. Red Bluff Research Pumping Plant installation. Note sealed inlet condition with rotating seal.

Rotating Seal. Within the 8-hour period of the initial burn-in test, shavings of UHMW (Teflon) seal material (between fixed pipe and rotating pump) were discovered in the discharge channels of the Archimedes pumps, and were accumulating on the wedge-wire screens. Upon closer inspection of the pump, it was determined that sediment from the river was migrating through the packing and lodging between the seal and the fixed roller pipe. This caused the seal to wear excessively. The pumps were shut down and the seal and packing were disassembled. Sediments in the size range of 1/8 inch and smaller had lodged between the UHMW seal and the fixed pipe, causing scoring and excessive wear of the relatively soft seal material, figure 14. Sediment traps were considered as a means to eliminate the sediment from the water prior to entering the intake manifold. This solution was quickly discounted due to the detrimental effects it would have on the inlet velocity and its low probability of success. A redesign of the seal was needed to allow operation with any amount and size of suspended sediments that may be pumped from the river. After several months of unsuccessfully working with the manufacturer to develop a solution without success, Reclamation designers developed a seal which could be manufactured and installed quickly and inexpensively. The seal eliminated large quantities of mechanical equipment and consisted

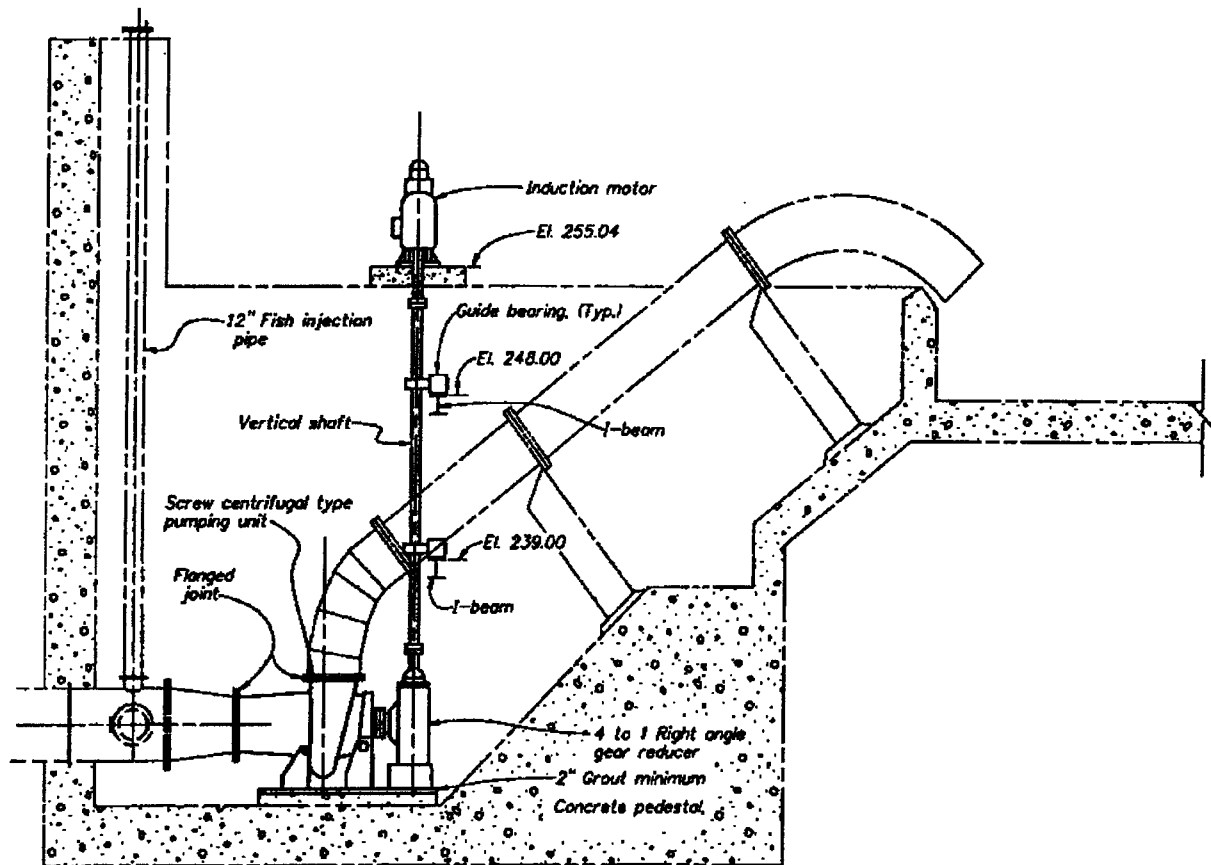
Figure 24. Wemco-Hidrostal centrifugal pump installation. *The Wemco-Hidrostal centrifugal pump installation at Red Bluff Research Pumping Plant*

centrifugal pump was used to begin the biological evaluations. The pump operation was initially very smooth; however, over the course of only 254 hours, shaft runout and pump noise forced the pump to be shut down on September 14, 1995. Upon inspection of the pump, it was discovered that the impeller had shifted radially along the pump shaft impinging the impeller on the intake manifold. A broken shaft had caused the pump to seize, figure 26. The impeller was shipped to the manufacturer's plant in Salt Lake City, UT, where it was discovered to be extremely out of balance. A new shaft was

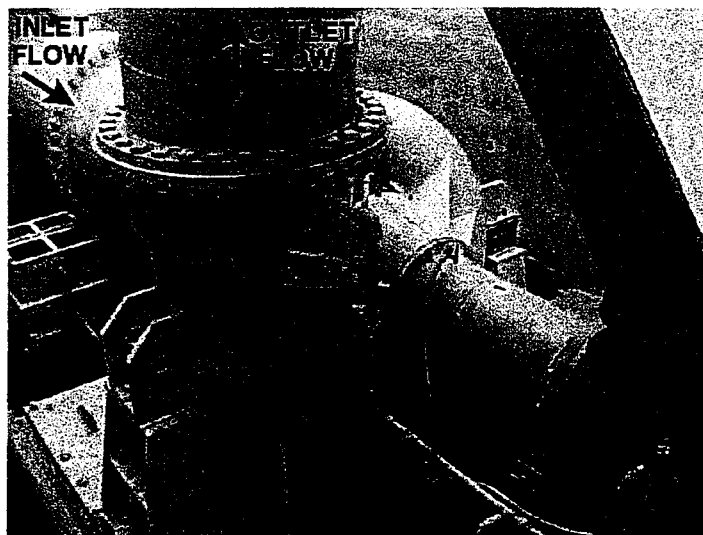
Figure 25. Flow path through the Wemco-Hidrostal Pump. *This photo shows the flow direction in the Wemco-Hidrostal (36X36) pump installed at RBRPP.*

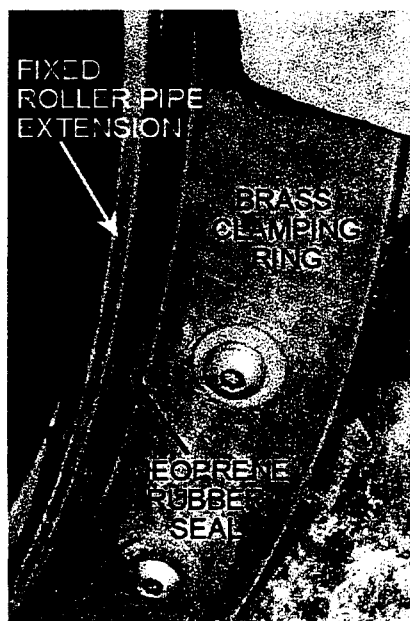
of two brass rings and a rubber seal, figure 15. The seals have performed well with little to no leakage or wear since installation.

Figure 15. Schematic of modified Archimedes inlet seal. *Detailed schematic of modified rotating seal installed in the two Archimedes pumps at RBRPP, photo shows detail of actual installation.*

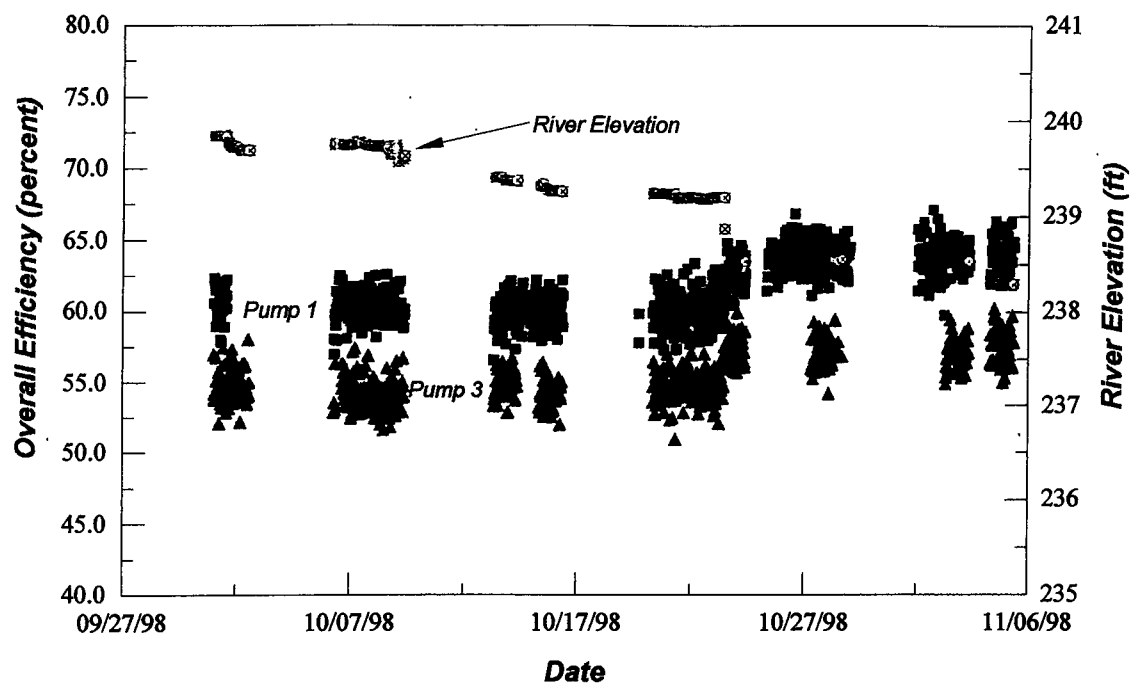
Water-to-wire efficiencies have been calculated for pumps 1 and 3, for the period October - December 1998, figure 28. The pumps were not operated from mid-November thru the end of the year, so the data are limited. Data are stored on a 30 minute interval. Efficiency values are quite low considering typical manufacturer's claims of 90-percent efficiency for the Archimedes pumps and 75-80 percent efficiencies for the Wemco-Hidrostral pump. These claims are of course for pump efficiency only, not including hydraulic, motor, bearing, and drive losses. In addition, for the Archimedes pumps, no data are available for a sealed inlet condition where the suction head is above the lower centerline setting of the pump.

Figure 28. Overall efficiencies for 1998. Overall efficiencies for Pumps 1 and 3 at the Red Bluff Research Pumping Plant for the last quarter of 1998.

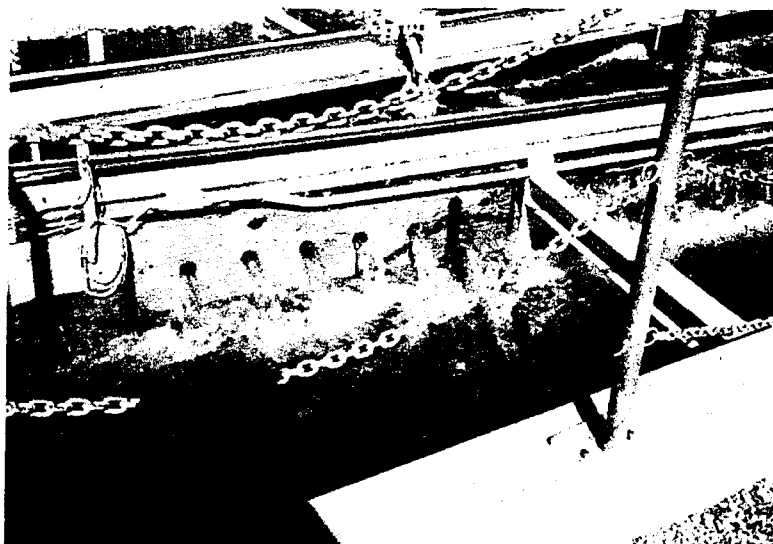
The first attempt at baffling was with fixed area baffles constructed of plywood and bolted to the backside of the downstream half of each side of the structure, figure 34. These were installed in July 1995. The screen panels closest to the bypass entrance were baffled with 10% open area, the next ones upstream at 25%, and the final baffles were at 50% open area. The upstream 3 panels on each side of the screen structure remained unbaffled. The baffling as a function of the complete screen area was 64 % open.

Figure 34. Temporary plywood baffles. *Plywood sheets with holes cut out created temporary baffles behind the wedgewire screens.*

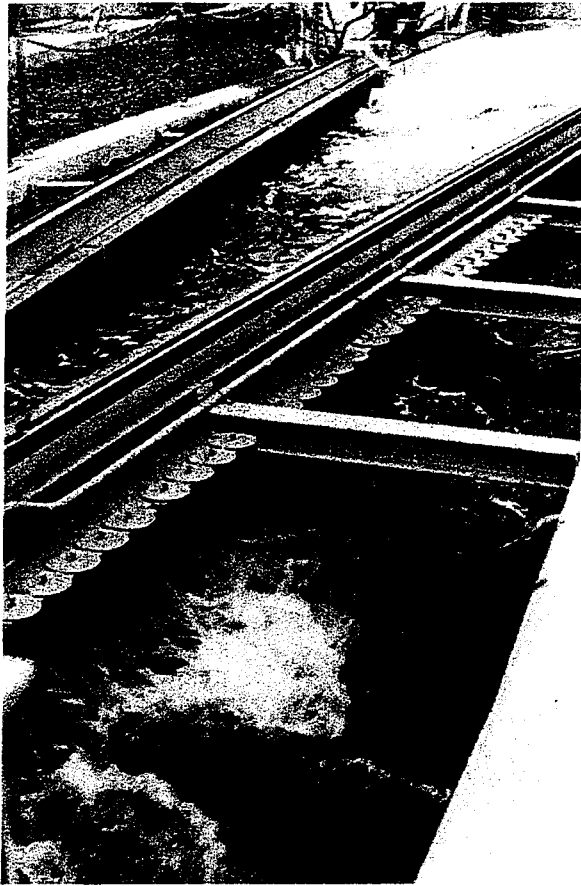
The early fish injection experiments also pointed out the problem with the velocity field entering the bypass, as many fish would hang up in front of the bypass entrance in the eddy zone created by the bypass ramp. Adjustable porosity baffles were constructed and replaced the *partial* temporary baffles in September

Figure 36. Adjustable baffles. *Adjustable porosity baffles cover the downstream half of the screen area in each bay.*

1996, figure 36. Several iterations of baffle adjustments were made between the baffle installation and summer 1997, with a complete set of measurements on all three pumps completed in July 1997. Some improvement in the velocity distribution and magnitude of approach velocities was accomplished, however, as baffles were closed off, the higher magnitude velocities migrated upstream to the first screen panel which was not baffled. Modification of the velocity distribution also helped lessen the strength of the eddy in front of the bypass entrance. Depending on the time of year and the debris load entering the screen structures, a moderate improvement in overall uniformity was achieved due to the "self-baffling" of the screens with debris. Deciduous tree leaves were especially effective in covering areas of high approach velocity on the wedgewire screens. In addition to the baffle modifications, an adjustable inverted weir was installed shortly after the adjustable baffles, at the bypass entrance. This weir had only a very localized effect on the bypass velocity and is generally recommended that it not be used, however, it does help maintain the water surface within the screen structure.

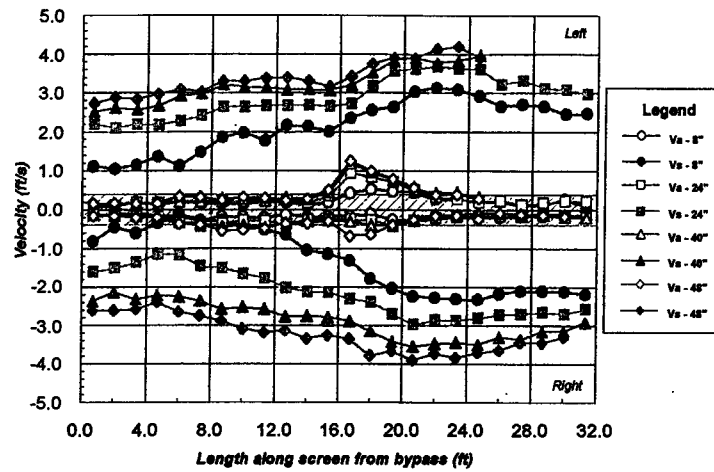
Detailed velocity measurements of the flow field in front of the wedgewire screens with the adjustable baffles in place were performed once again in the summer of 1998. Measurements were performed on pump 2, an Archimedes pump operating at 26.5 rev/m. Results show that the approach velocities near the bypass entrance were within criteria, however, just upstream from the beginning of the baffles, high approach velocities still exist, figure 37. The uniformity of the velocity field was also slightly variable, especially side to side. It became clear that it was necessary to baffle all the screen panels to affect the entire velocity field. Plywood baffles with a 25-percent open area were installed behind the remaining unbaffled screen panels. The measurements were repeated and showed much improvement in both magnitude and uniformity, figure 38. In general, the approach velocities met the 0.4 ft/s criteria at almost all points measured. The area in which criteria is exceeded is most likely due to the influence of surface waves impacting the wedgewire screen. The waves are noticeable in the Archimedes pump

Figure 37. Velocity measurements for partially baffled screens. ADV measurements for partially baffled screens of pump 2, $Q=87 \text{ ft}^3/\text{s}$. Measurements are for various depths above the channel bottom.

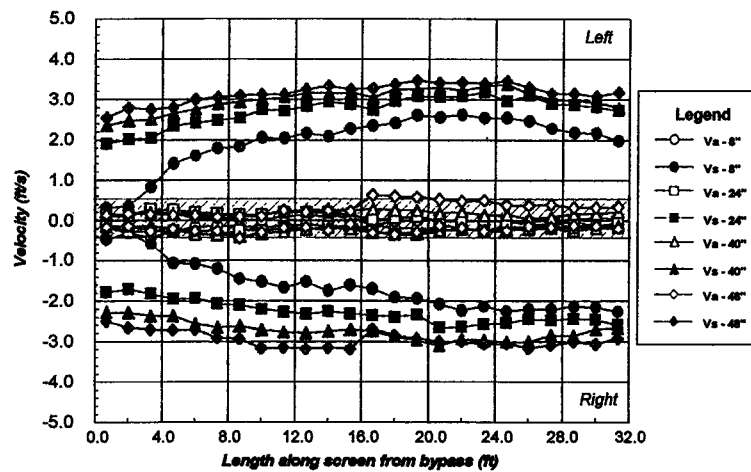
Figure 38. Velocity measurements for fully baffled screens. ADV measurements for fully baffled screens of pump 2, $Q=87 \text{ ft}^3/\text{s}$. Measurements are for various depths above the channel bottom.

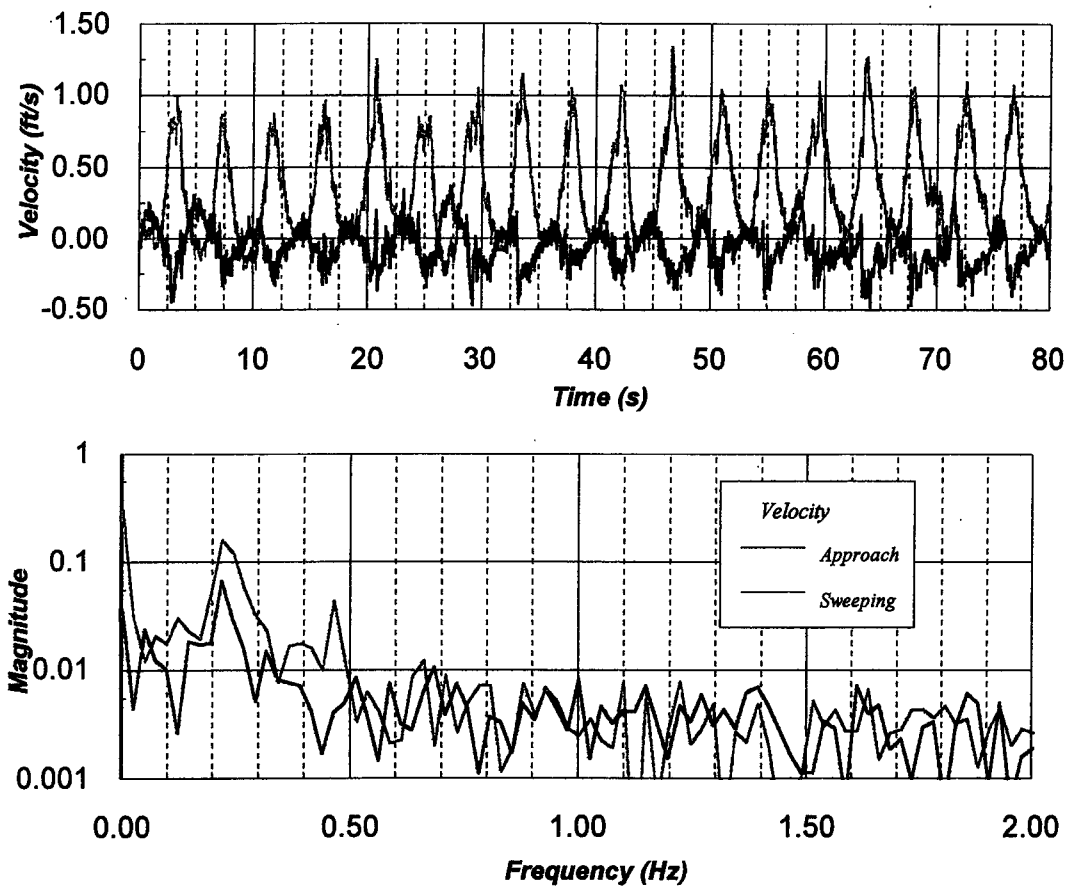
channels and the frequency is a function pump speed. At maximum speed (26.5 r/min) the dumping frequency of the flights is 1.325 Hz, and while not noticeable in the actual velocity traces, the water surface is definitely not smooth. As the rotational speed of the pump is slowed down using the variable frequency drive, the waves or pulsing action of the flow does become noticeable in the actual approach and sweeping velocity measurements, figure 39.

Figure 39. Velocity measurements with the Archimedes pump rotating at 4.42 r/min. Time series and frequency information of the approach and sweeping velocity components from pump No. 2, operating with the VFD at 10 Hz, giving a rotational speed of 4.4167 r/min and a dumping frequency of 0.22 Hz, $Q=12 \text{ ft}^3/\text{s}$.

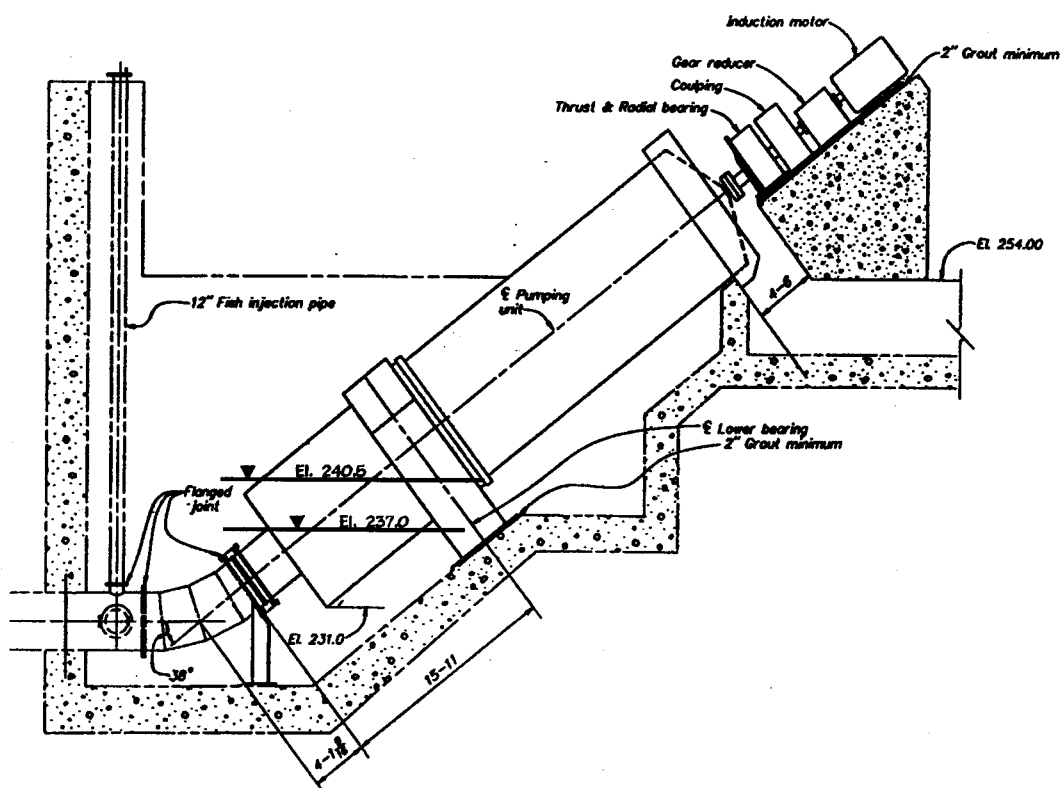
The major design issues with the Archimedes pump involved the rotating seal at the inlet to the pump and the design of the internal flights. Most of the additional problems including failures of couplings and bearings were due to the initial installation being well out of alignment. The rotating seal provided by the pump manufacturer failed within hours of the startup. After several months of trying to work with the manufacturer, Reclamation finally designed and installed a seal which has been performing very well. There has been little or no maintenance required, and leakage was minimal. Cracking of the pump's internal flights was the other major design issue. This problem was a result of both an overload and poor workmanship of the flight-to-flight welds. The cracking began at an abrupt contour change and the beginning of a weld. This type of junction typically has a large stress concentration factor. In addition to this workmanship issue, finite element modeling showed that the size material used for the flights were inadequate. Reinforcing plates were added to each side of the flights over a portion of the pump's length. Through this modification as well as the weld repairs and stop-drilling, most of the cracking has stopped. The setting of the pump elevation in the structure may be a major cause of the cracking due to the high static water loading inside the pump. The lack of experience with a variable water surface at the inlet to the Archimedes pump raises the question as to whether a higher pump elevation setting should have been used. Figure 43 shows the minimum and maximum design water surfaces and how they relate to the pump setting.

Figure 43. Elevation setting of the Internallift Archimedes pumps. *Design settings for the Archimedes pumps at RBRPP. Note specified minimum and maximum water surface elevations for pumping, actual maximum was actually closer to 245.*
